Preventing Disasters :

On-Site Frequency Analysis of Jet Fans

tunnelventilation.Pro IP Engineering GmbH

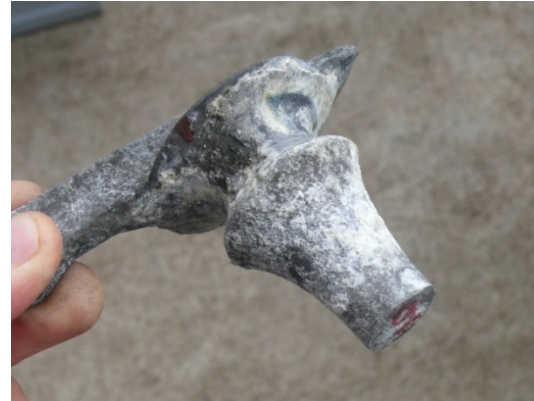
Blade breakage in jet fans, rare but dangerous

Appearance of the fractures :

- > All blades are torn off at the blade foot
- > one blade showed a large corrosion surface after previous crack formation
- > all other blades showed a forced breakage after previous impact load

Cause : Stress corrosion cracking?, Vibrations?

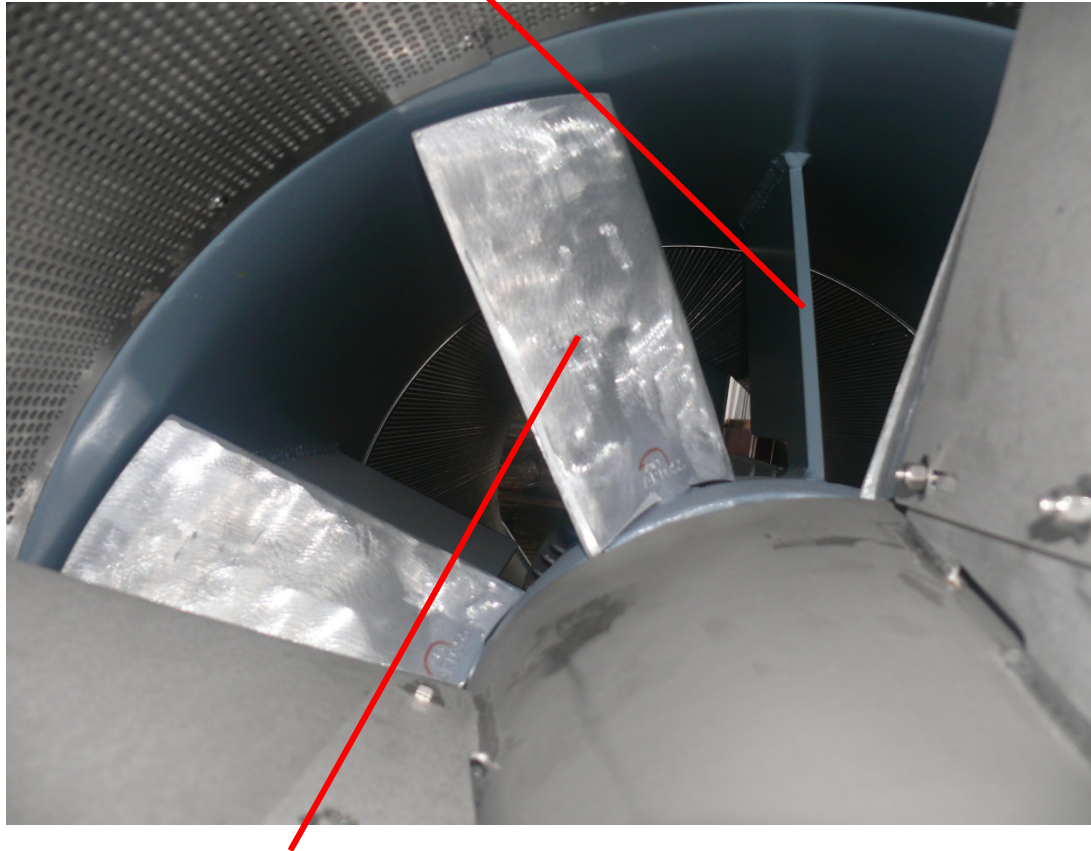
Aerodynamic Excitation in Jet Fans

Excitation of struts by n_l rotating blades per rotation

Excitation of rotating blades by n_s struts per rotation

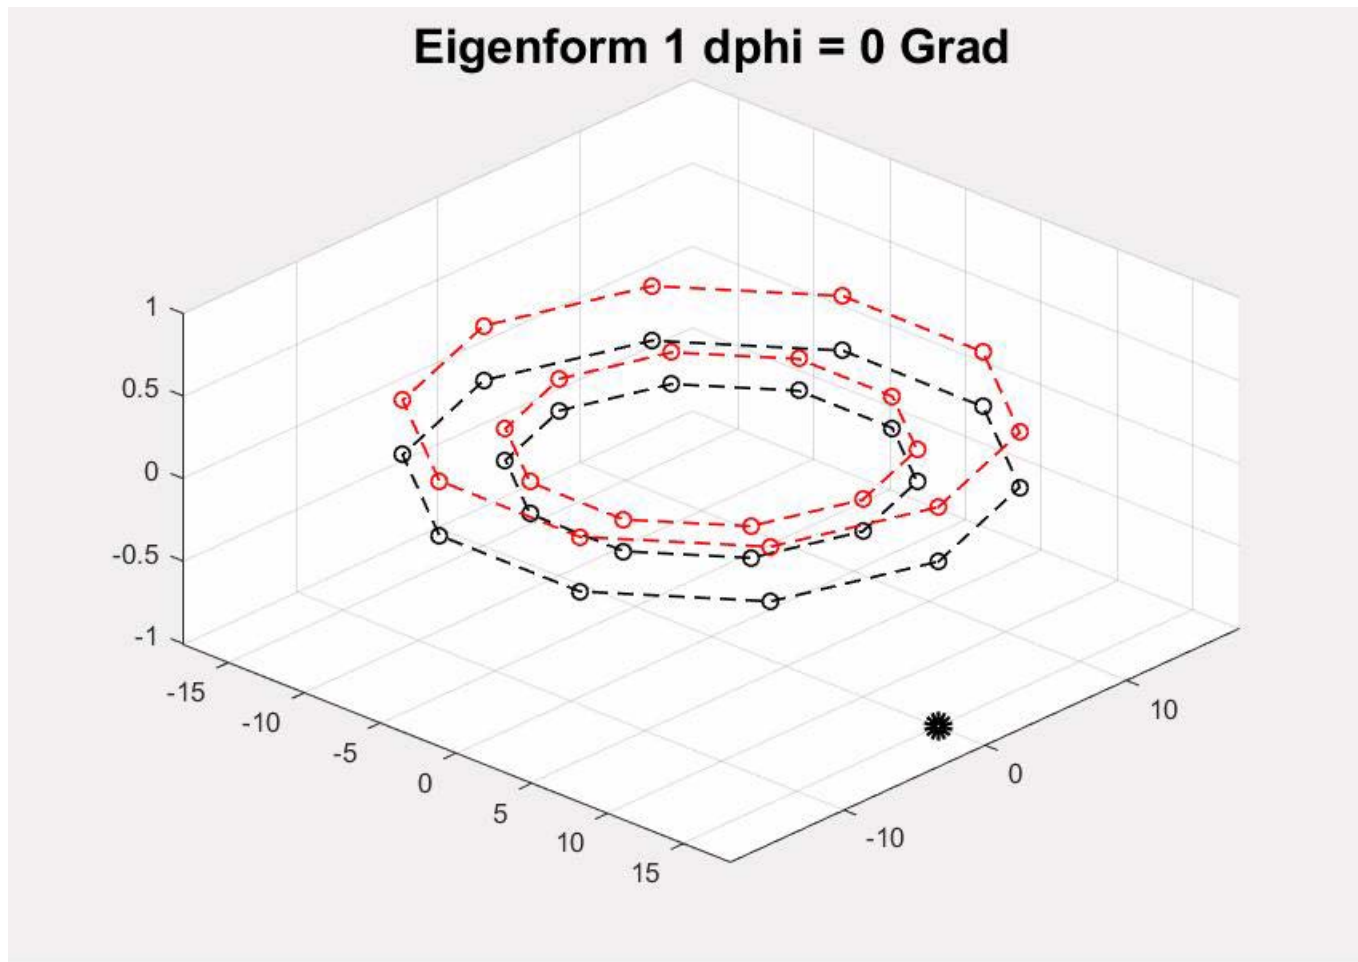
The first 5 natural modes of the blade ring

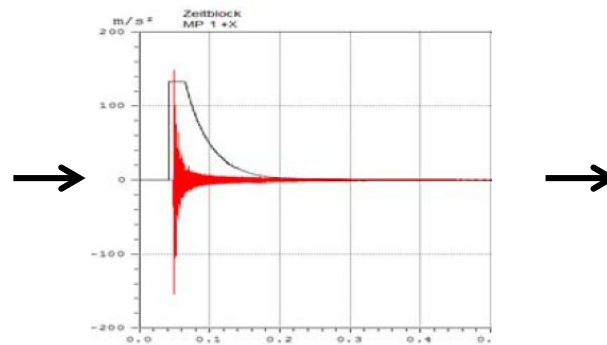
Response signal in time domain

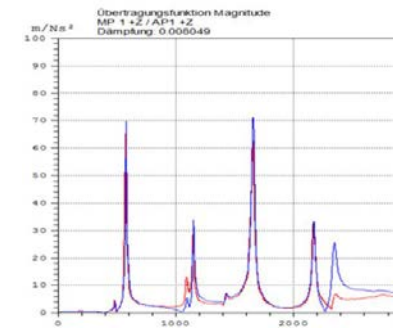
Frequency spectrum

- > Regular monitoring of the natural frequencies
- > If significant deviations from the original condition visual inspection and replacement if necessary

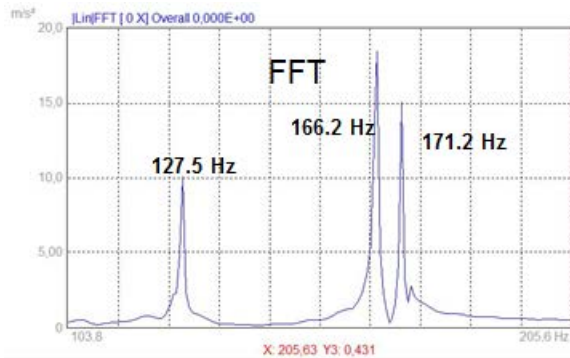
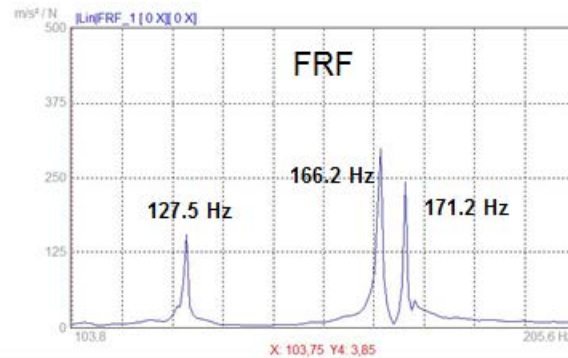
undamaged

Detecting a crack through frequency reduction

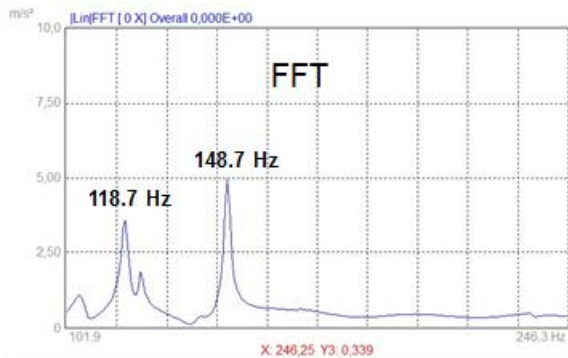
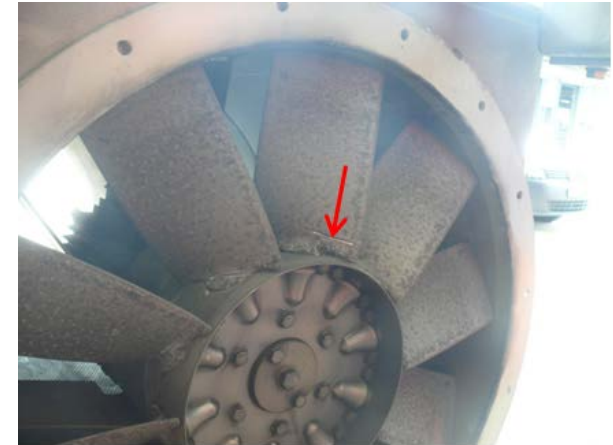
damaged

Significant reduction of eigenfrequencies of 2nd and 3rd mode, peak of 1st mode almost vanished

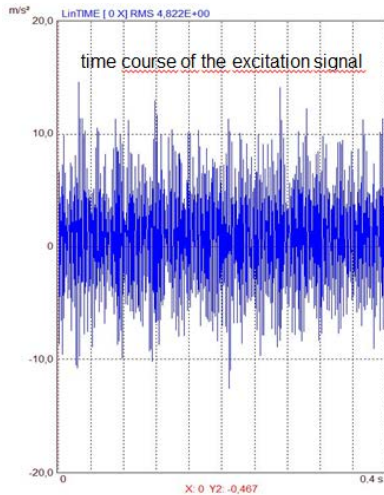
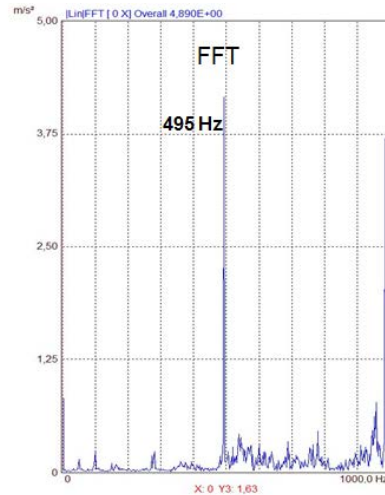
Measurement of forced vibrations on a fan during operation

Time signal of vibrations at the casing

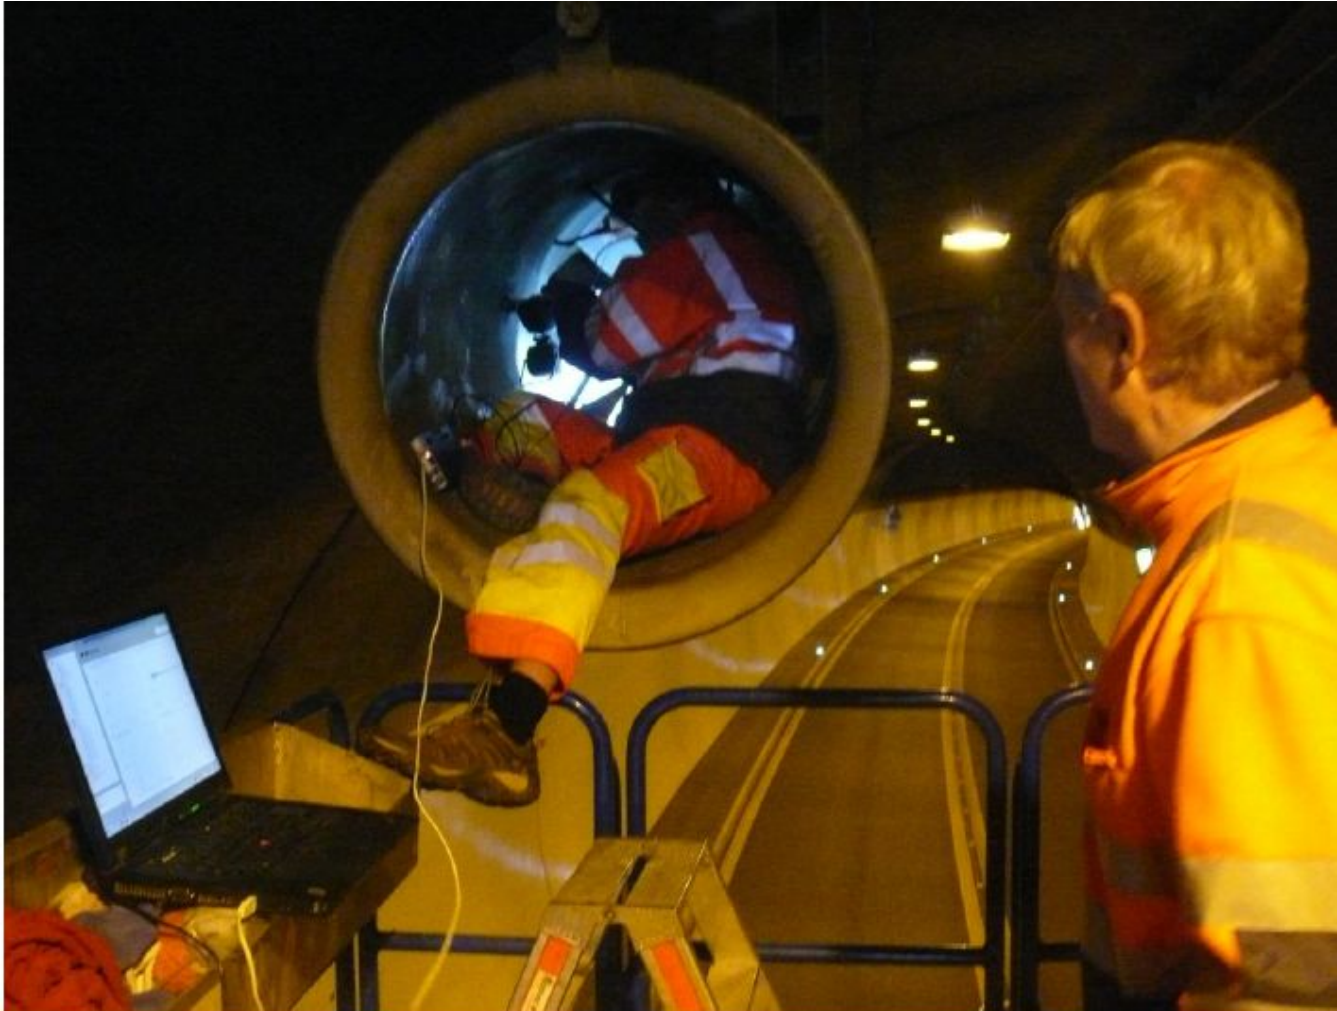
Measurement of eigenfrequencies of fan SV3 in the Flüelen Tunnel
